HISTORIC STRUCTURES REPORT

BRICK WALKS

WILLIAM HOWARD TAFT NATIONAL HISTORIC SITE

Mark A. Chavez, Regional Historical Architect

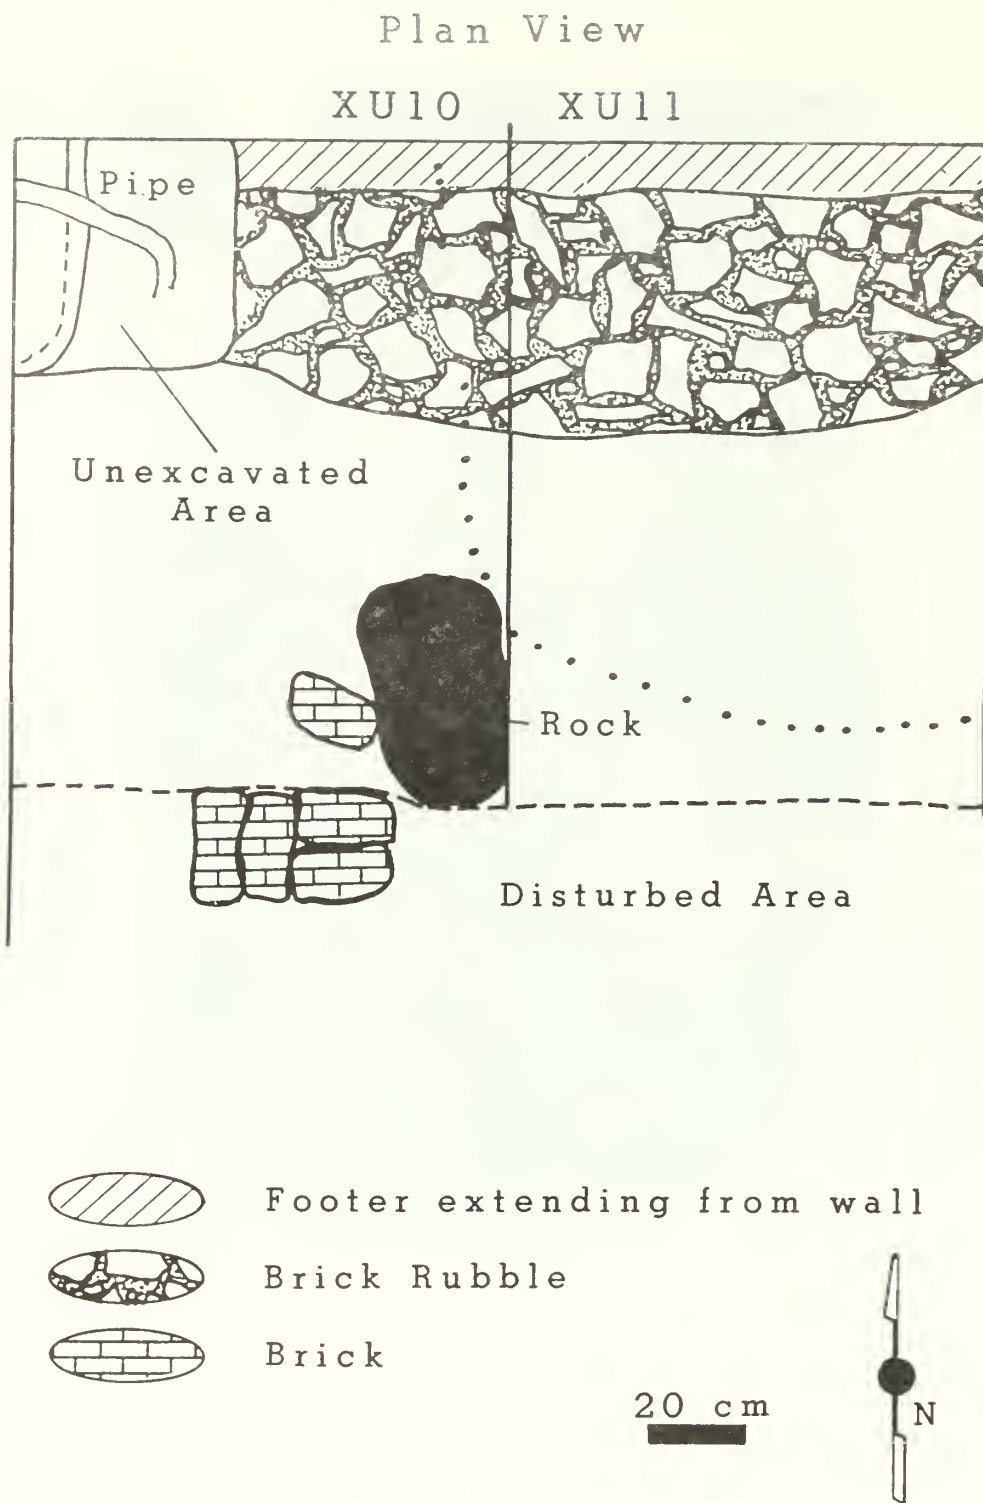
FIGURE 3.27

Along the southern border of the [XU 10] unit, resting on sterile clay, were five bricks laid in a disrupted herringbone pattern (Figure 8) [see Figure 3.27]. As in XU 6 and the south porch area excavated by McCollough (1972:30), the bricks rested on sterile clay. In association with this was a roughly dressed limestone rock measuring ca. 8 cm [about 3 inches] in thickness. The surface of the bricks was 13 cm [about 5 inches] below the surface of the footer, while the top of the rock was parallel with the top of the footer and the foundation line in the interior of the basement (Figure 8) [see Figure 3.27]. All artifacts lay on top and in between the bricks. No materials were recovered from

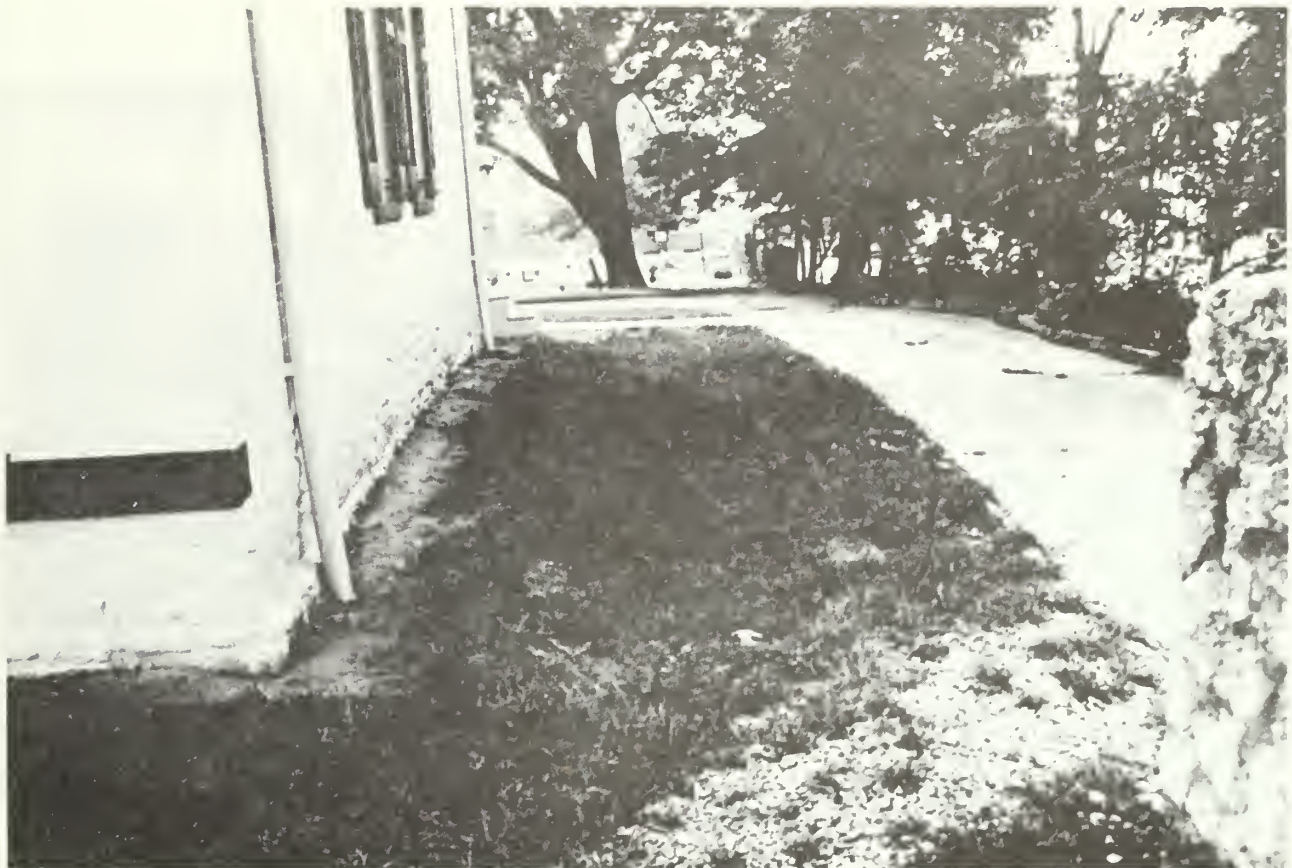
FIGURE 4.7

The historic brick walk was located approximately 2-feet from the south exterior wall of the house.

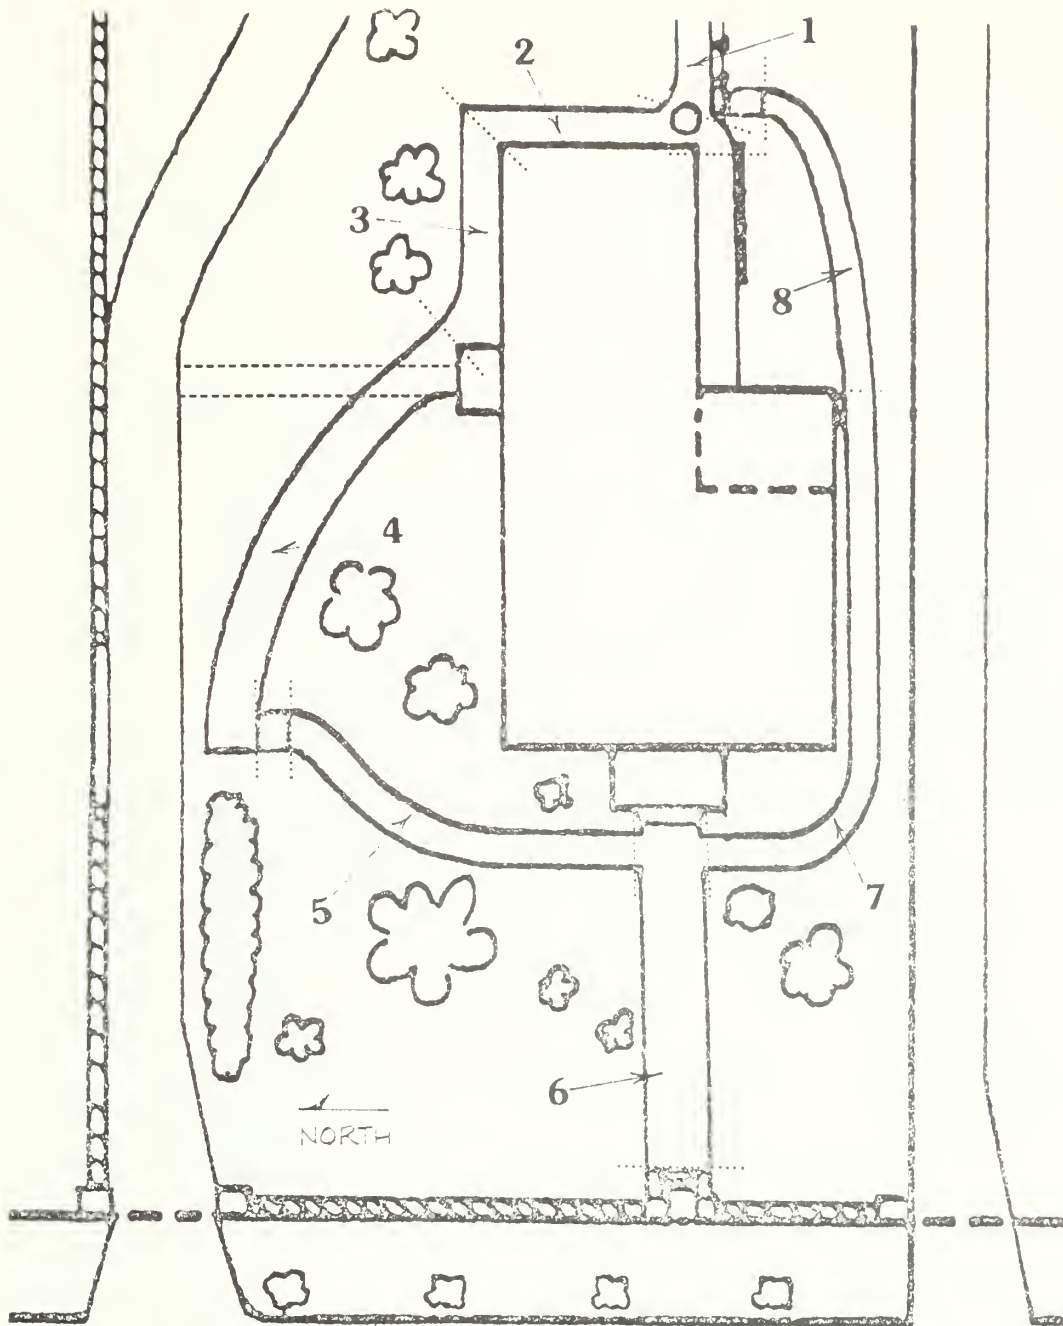
FIGURE 5.1

This figure approximates the grounds as McCollough envisioned them historically. The numbers refer to specific walks referenced in the text.

For the purposes of this report, Walks 2, 3, 6, and 7 will be reconstructed based on conclusive historical and archeological research. The privy walk (number 1) has also been supported, but regrading of the existing site will have to be accomplished prior to its reconstruction. Walks 4 and 5 will remain as concrete sidewalks until further archeology can be performed in these areas. Walk 8 will not be reconstructed at this time.

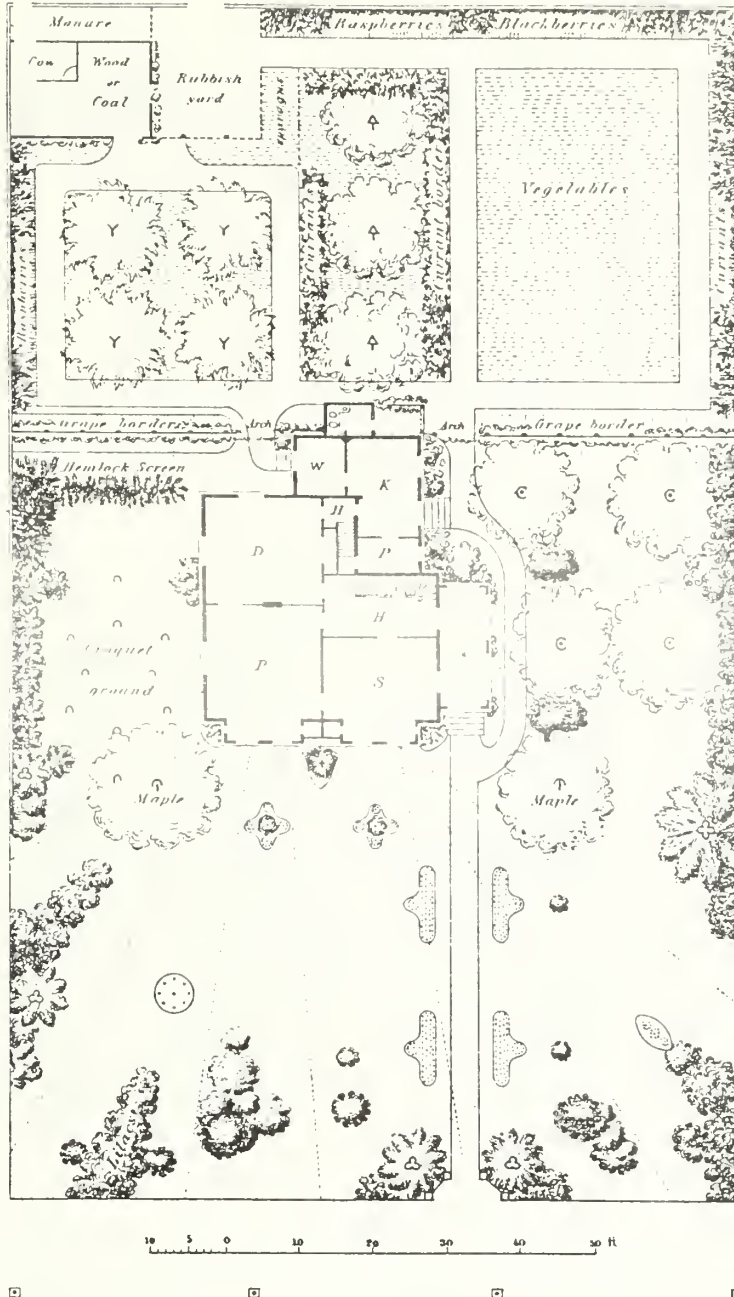
FIGURE 5.3

This figure and the succeeding four figures indicate possible arrangements of walks around homes of the nineteenth century. Note the walk which leads from the main entrance around to the kitchen in each case, possibly supporting a similar case for the Taft home. (Unsupported historically or archeologically).
